**INSPECTION REPORT  
Lanxess Storm Sewer Leak/Discharge  
To AOC 2 Former Ponds Remediation Area**

**HATCO CORPORATION SITE  
FORDS, NEW JERSEY**

**July 2018**

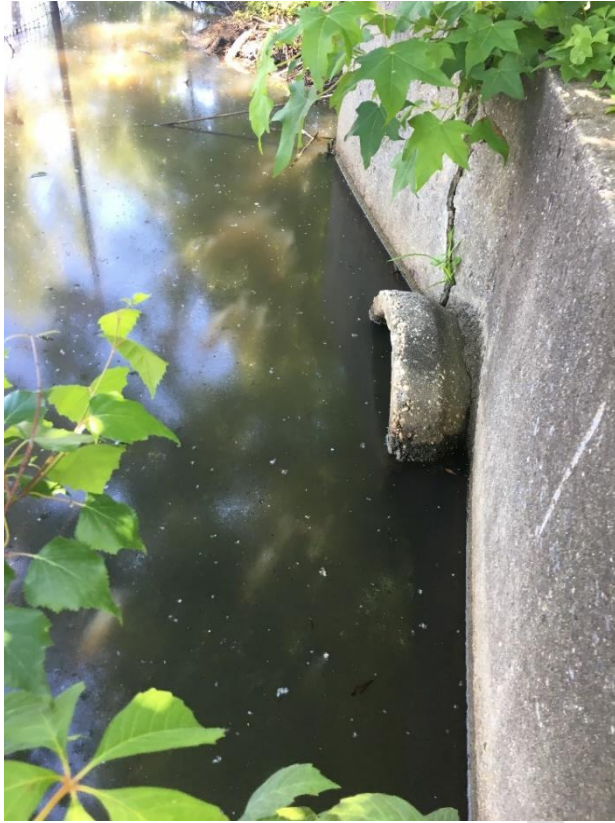
There is an outfall at the western side of the pond (see Photo 1).

Photo 1 – Outfall in west side of pond

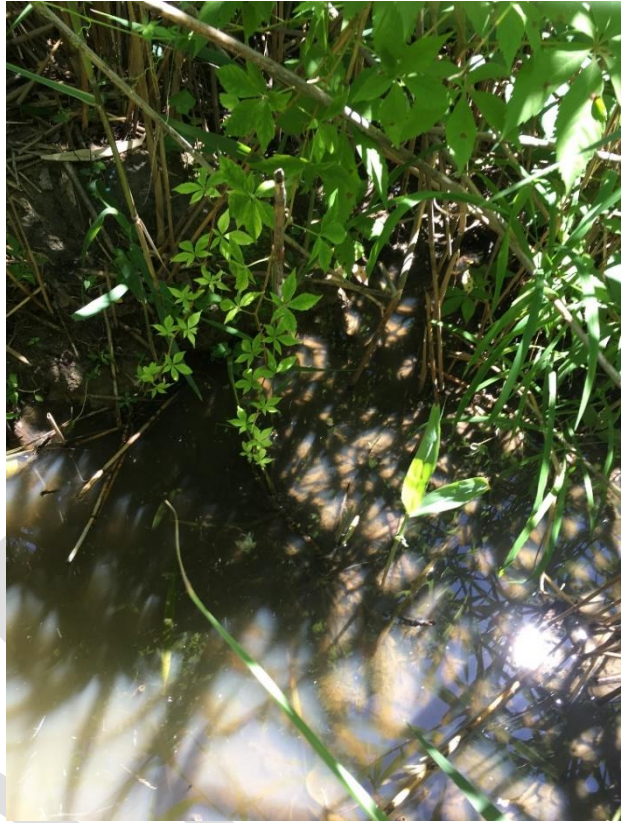
At approximately 14:15, Jason Schindler and Coleen Devorak of Weston inspected the area of the outfall. No evidence of LNAPL, staining or sheen was present in the pond near the outfall or in standing water downstream from the outfall (see Photo 2).

Photo 2 – Standing water west of pond outfall

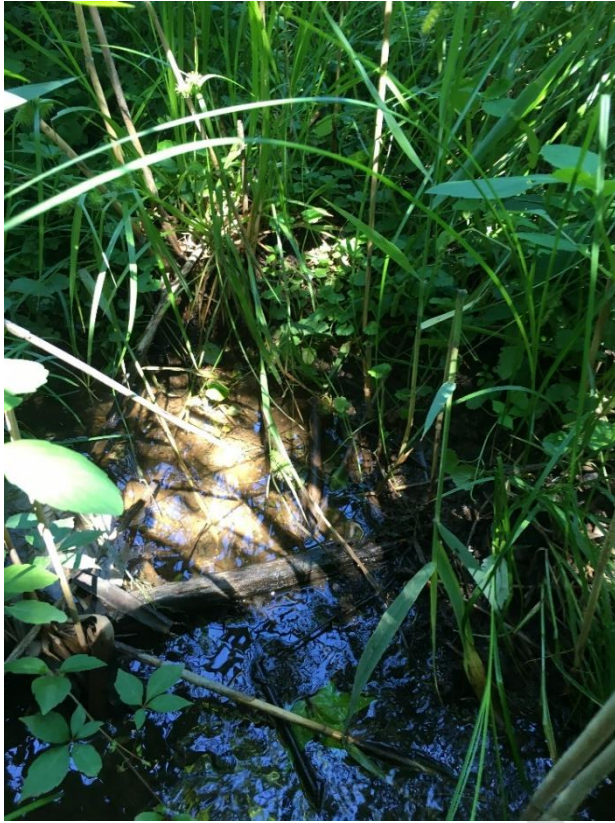
At approximately 14:30 Schindler and Devorak inspected conditions in Channel A, downstream from the pond. No evidence of LNAPL, sheen or odor was detected (see Photos 3 and 4).

Photo 3 – Channel A downstream from outfall at Channel D

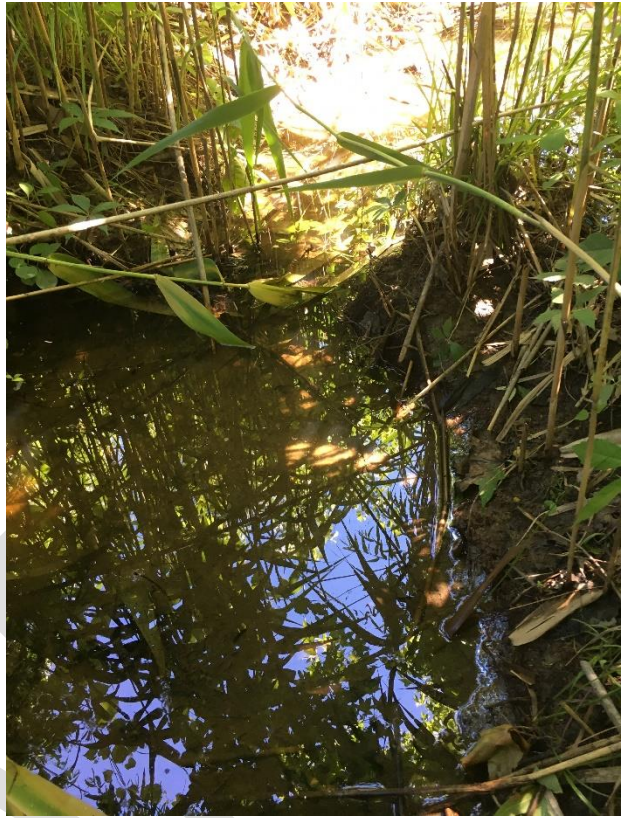
Photo 4 – Channel A upstream of confluence

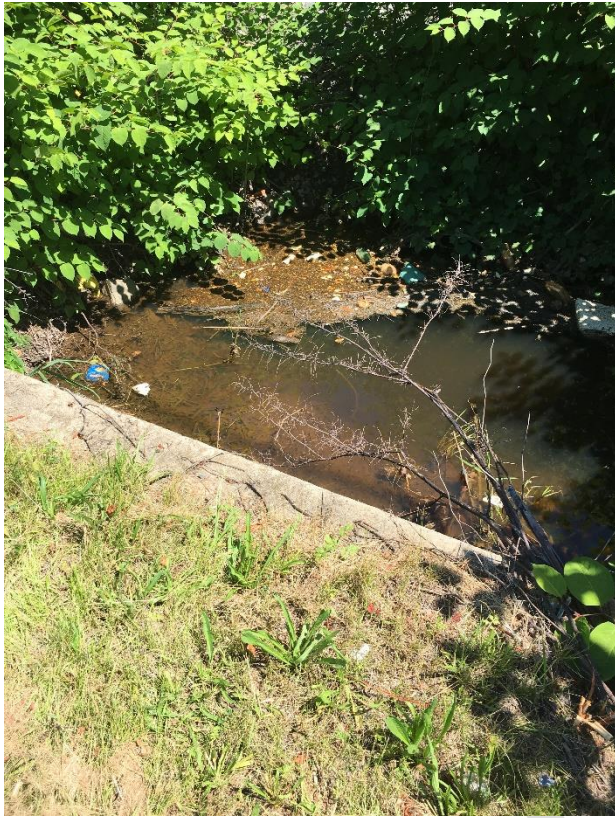
At approximately 14:40 Schindler and Devorak inspected conditions where Channel D crosses Riverside Drive. No evidence of LNAPL, sheen or odor was detected (see photos 5 and 6).

Photo 5 – Channel D south of Riverside Drive

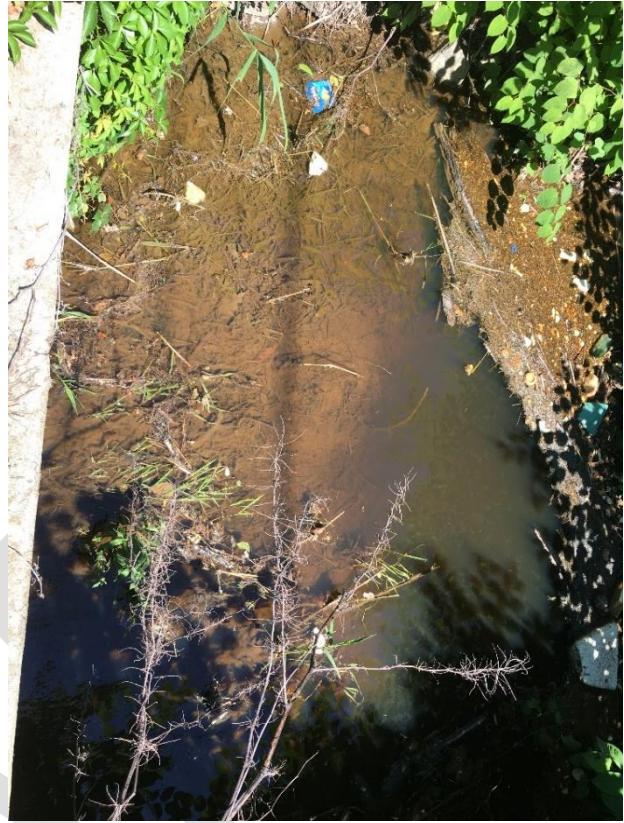
Photo 6 – Channel D south of Riverside Drive

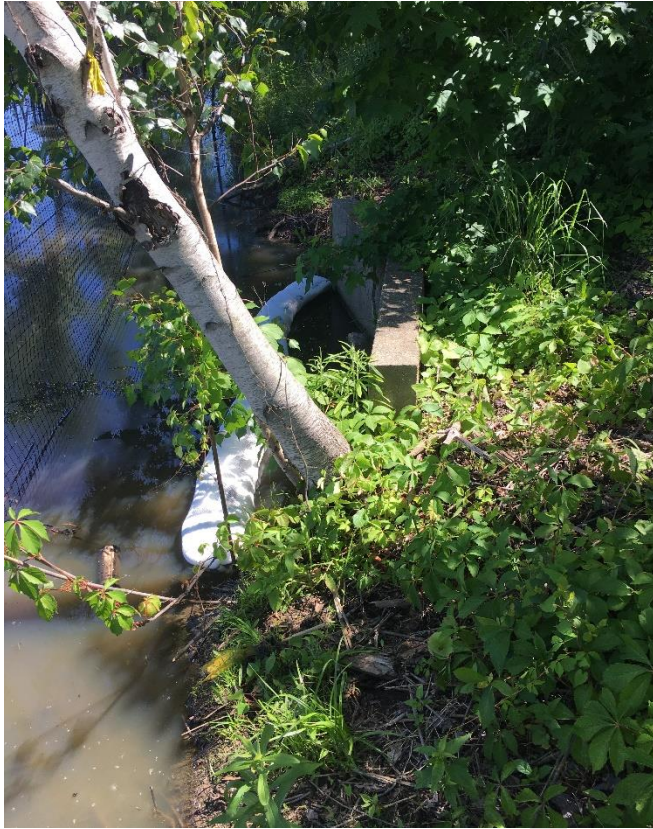
Photo 7 – Sorbent boom placed across outfall

At approximately 14:50 Schindler placed sorbent boom in front of the pond outfall (see photo 7)

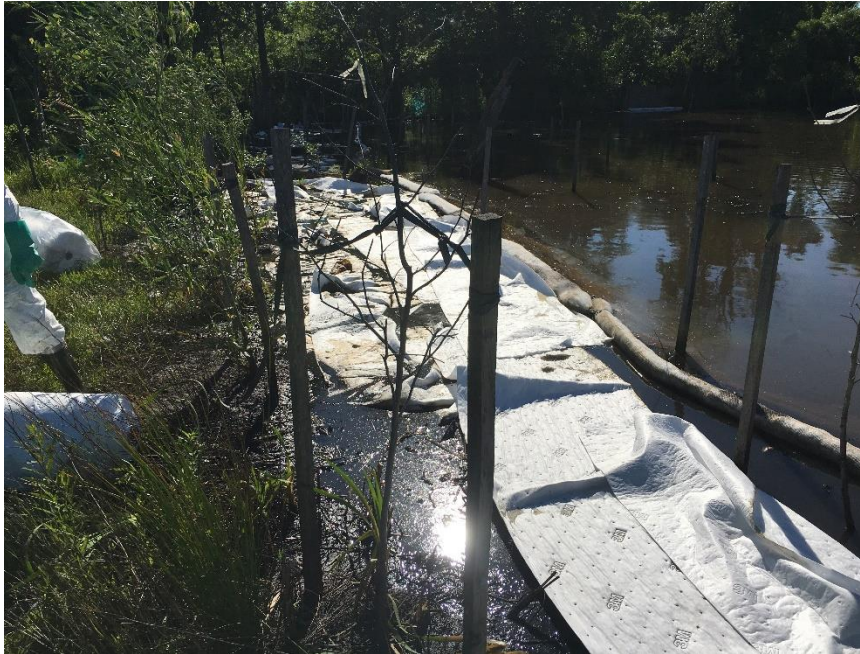
Photo 8 – Sorbent placed in south side of pond, looking northeast.

Between approximately 14:45 and 17:30 Marat Mardenov, Mike Argue, Coleen Devorak and Jason Schindler of Weston installed sorbent boom and placed sorbent pads to recover the LNAPL observed in the southern portion of the pond. (see Photos 8 and 9). The area was secured overnight.

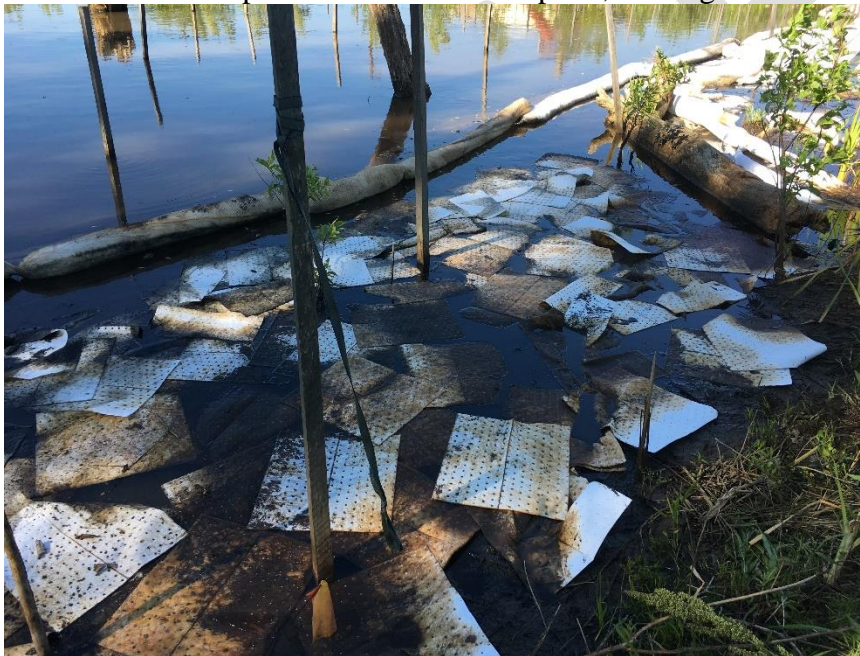
Photo 9 – Sorbent placed in south side of pond, looking northwest
